THE MAINTANCE OF GEOMETRICAL PARAMETERS OF CONSTRUCTIONS WEIRS AND THEIR DURABILITY

Wojciech ANIGACZ
Opole University of Technology, Opole

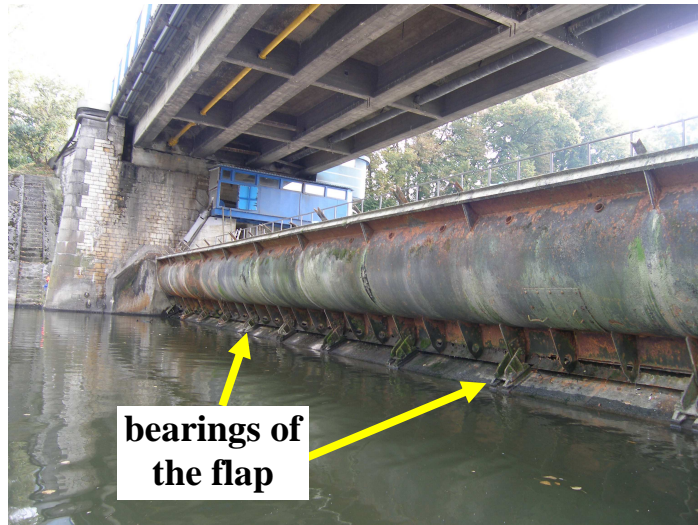
Fig. 1. The flap of weir before exchanging, view from the side of tail water

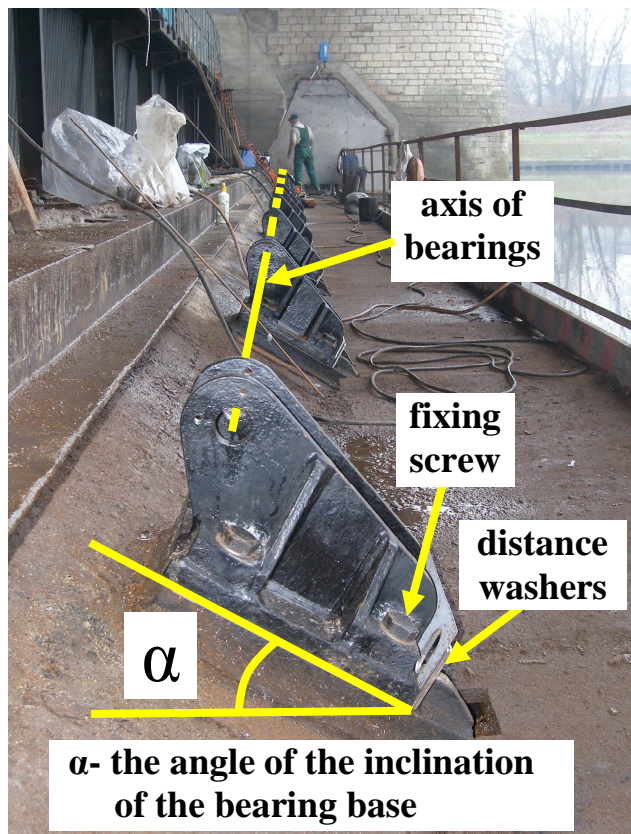
The flap width amounts at 30,0 m, fig.1. The scope of survey works comprised the coaxial positioning of bearings of the weir at the time of its renovation, fig.2. Both the investor and the designer set the alignment accuracy at least 0,3 mm [3]. The lack of smooth adjustment of positioning of the bearings was an obstructive factor in obtaining the required accuracy. When adjustment was needed, it was necessary to unscrew the whole bearing, put on or take out a distance washer of relevant thickness and screw it up again. The number of such operations was considerable and it required high qualifications from the workers as well as relevantly long time.

Fig. 2. The bearings of the flap

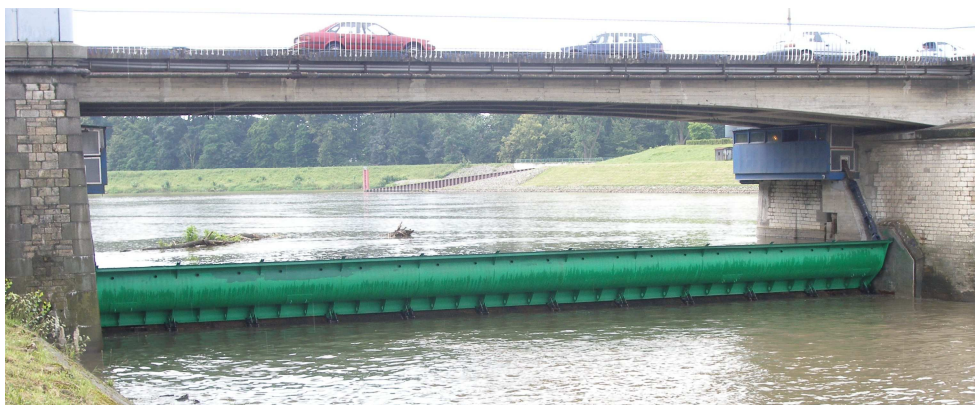
Fig. 5. The flap of weir after exchanging, view from the side of tail water

Coaxial of the bearings axis has been set out with the required accuracy i.e. 0,3 mm. Measurements were executed with use of standard instruments and supporting equipment of renowned brands as well as the contractor's own innovatory solutions of the highest accuracy parameters.
