THE MAINTANCE OF GEOMETRICAL PARAMETERS OF CONSTRUCTIONS WEIRS AND THEIR DURABILITY

Wojciech ANIGACZ
Opole University of Technology, Opole

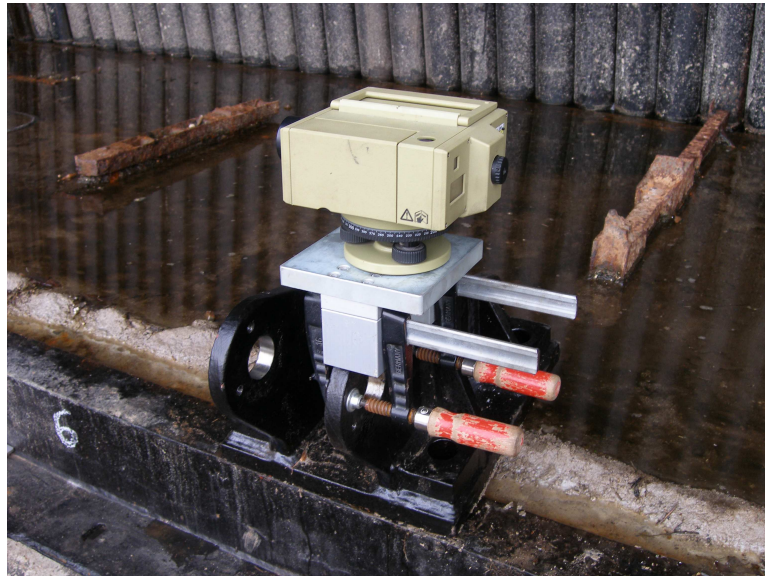
Fig. 3. The level NA 3003 on the observation station

Positioning of the bearings in vertical plane was measured by a total station Leica NA 3003 and a code invar leveling staff (fig.3). Due to lack of space, a special stand was used to put the survey instrument. Coaxial survey was made according to the constant straight line method. It has been assumed (following agreement with the investor and the contractor) that the reference straight line would be the line marked by the ending bearings.

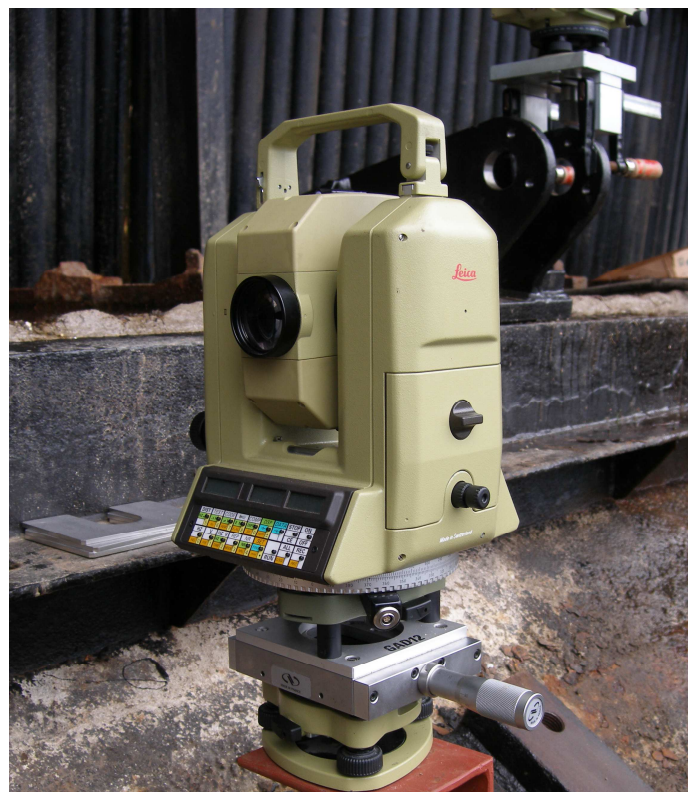
Fig. 4 .Total station TC 2002 with precision translation stage GAD12

The survey points were signaled using special targets. To increase survey accuracy and to define numerically the deviation from a straight line, a precision translation stage GAD12 was used with a micrometric screw of 0,01mm accuracy, fig.4. The task described just in one sentence took the surveyors two working days, fig.5.
